Multibeam Bathymetric Measurements for Shallow Seabed Features Mapping using Unmanned Surface Vehicle

¹Pertamina Hulu Mahakam

²PT Elnusa Tbk

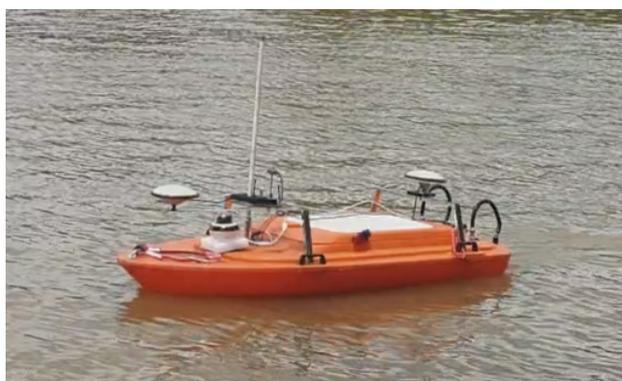
Figure 3. USV Barelang deployed on site

The USV deployed for data acquisition were the USV Barelang series (Figure 3), with dimensions of 1.8m in length, 0.95m in width and 0.8m in height (including the antenna radio link). She weighed at 50kg with the battery and Multibeam Echosounder (MBES) included. She was able to cruise at a speed of 3 knots with around 4 hours battery power. The distance of telemetry radio communication to pilot, based on local conditions, was approximately 200-300m due to dense vegetation on location.

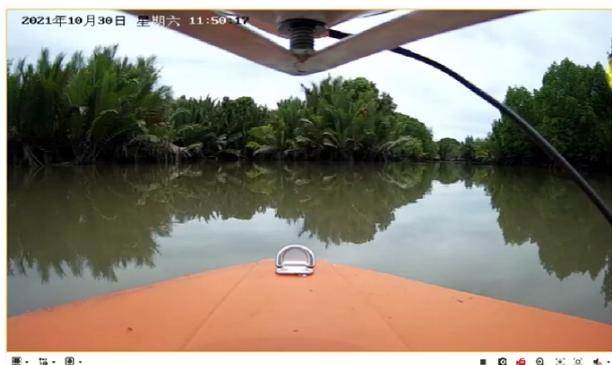
Figure 8. Screen shot from camera 360 multi beam echo sounder USV

Bathymetric data were collected using the R2Sonic 2020 MBES system. The system provided narrow beam widths at 700 kHz operation which allowed a $2^\circ \times 2^\circ$ beam width. The USV was equipped with a 360-degree camera attached to the top part of the vehicle. The camera helped the pilot keep the USV on a straight path (Figure 8). Acquired MBES data were recorded in Eiva Software as well as on-line navigation data, and then processed using offline Eiva Software at the office. The processed bathymetric results are presented in a color chart on the bathymetric image as shown on (Figure 9).
